ADDITIONAL INFORMATION REQUIRED FOR

ANACONDA COPPER COMPANY'S

JACKPILE-PAGUATE

RECLAMATION PLAN

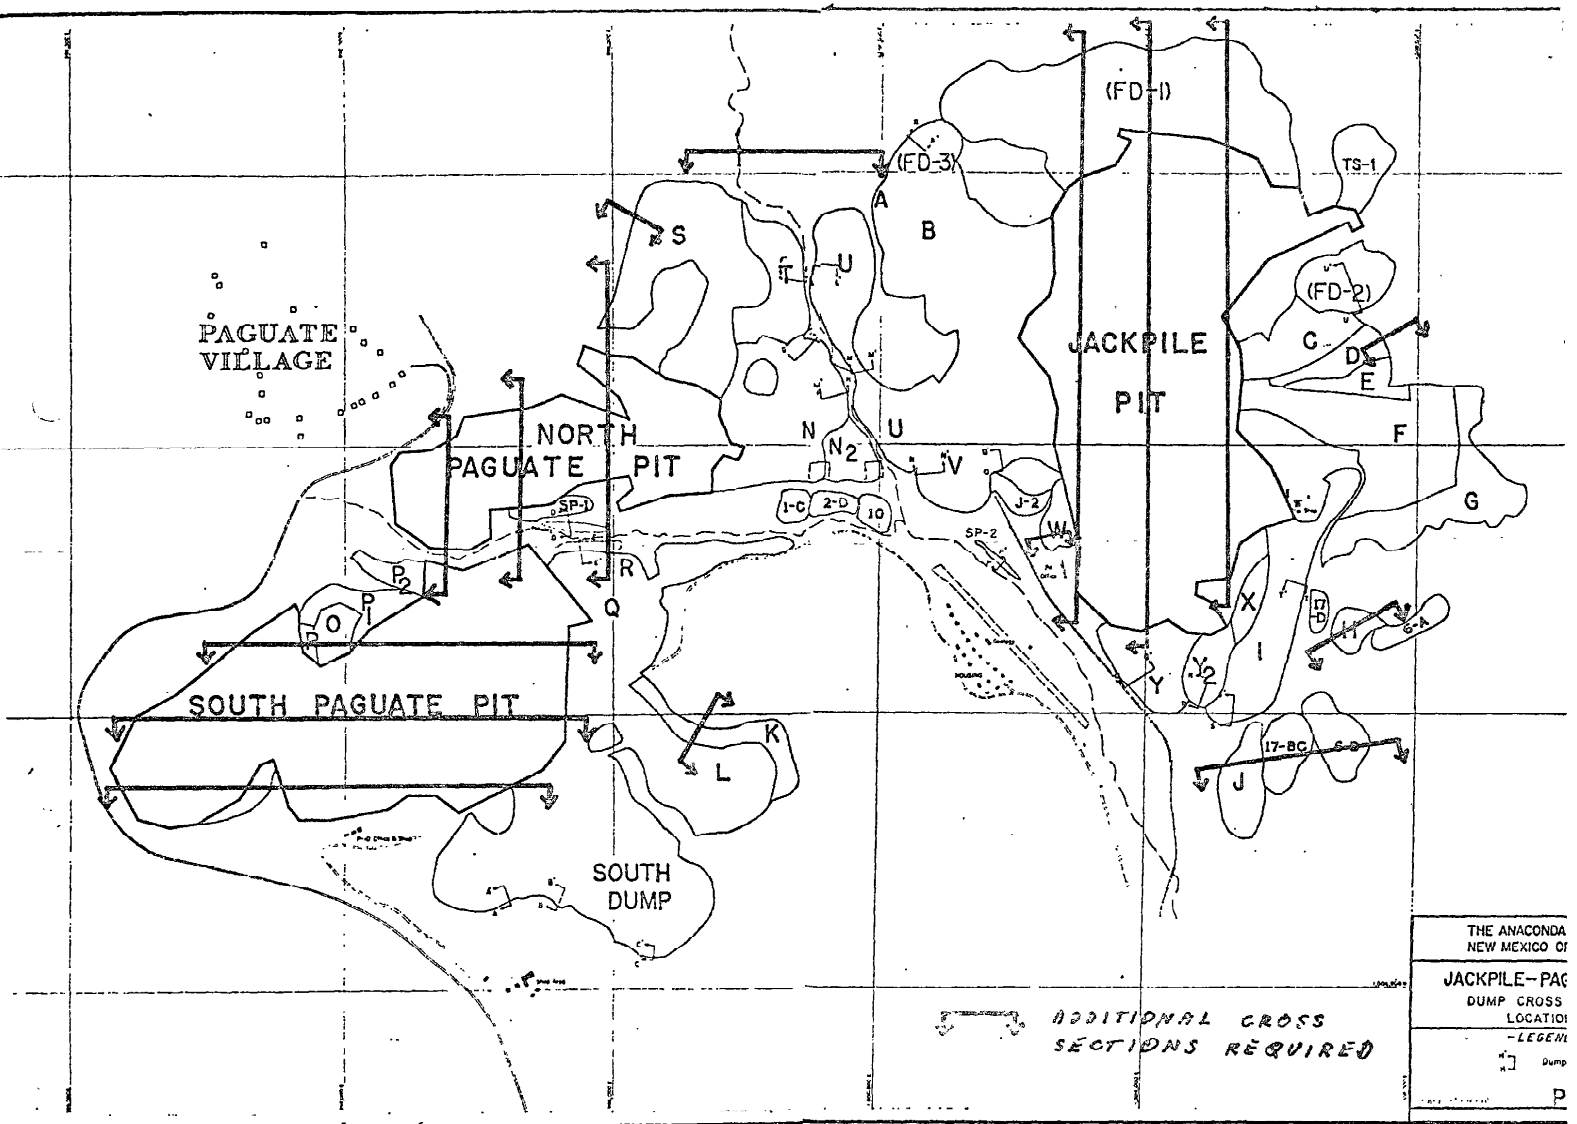
1. To adequately assess the final reclaimed land forms, additional detail must be provided. Please submit the cross-sections shown in red on the attached map.
